El Dorado Fire 2020

Date of Report: October 6, 2020

BURNED-AREA REPORT

A. Fire Name: El Dorado

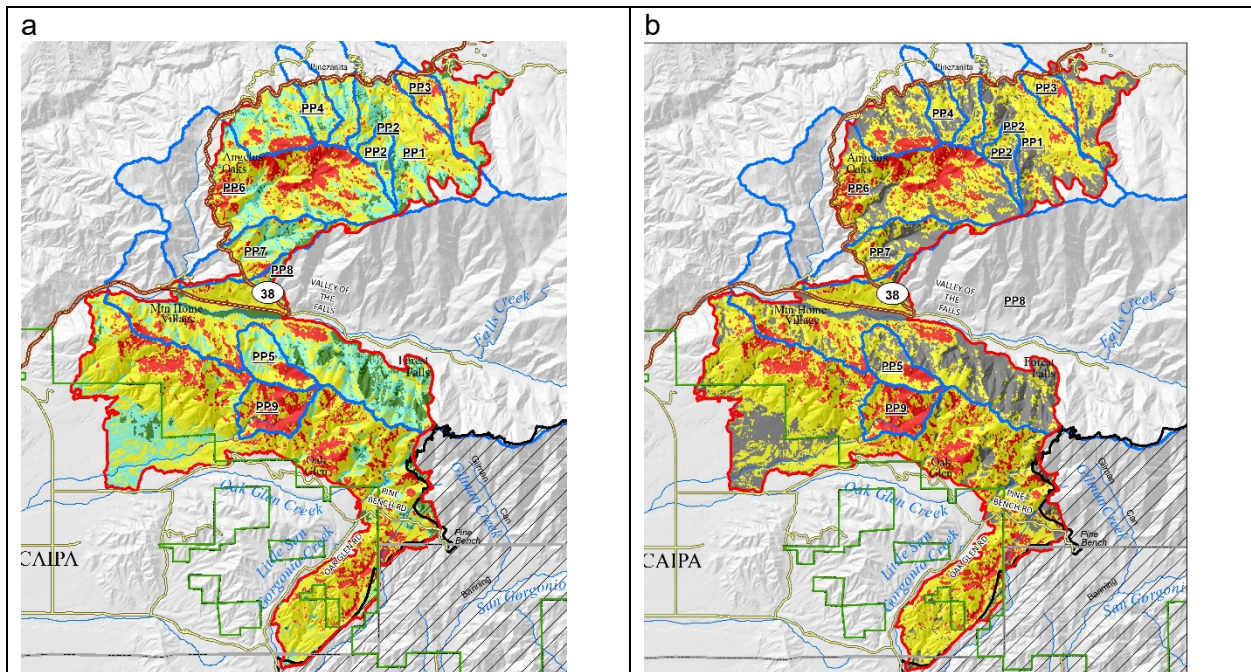
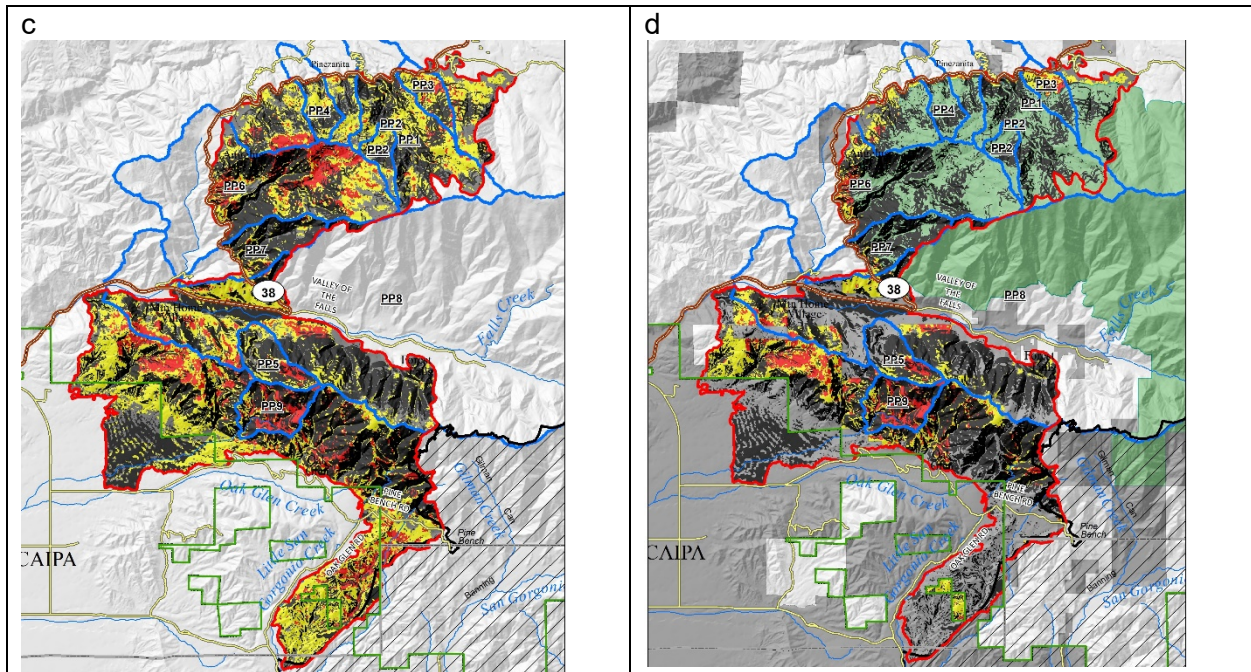
Figure 1- Limitations to hillslope treatments on Forest Service Lands

Figure 1 below shows limitations that restrict the area available to hillslope treatments, such as aerial mulching. Figure 1A shows soil burn severity within the El Dorado Fire. Low and very low burn severities are greyed out in 1B because these SBS classes typically retain ground cover and erosion rates are low. 1C blacks out slopes that are steeper than 60%, where hillslope treatments are not effective, and less than 10% where runoff energy is low and treatments are not necessary. Finally, 1D grays out non-Forest Service lands and wilderness where the forest service can not recommend treatments. The remaining areas, shown in red and yellow on 1D are slopes where hillslope treatments such as aerial mulching could technically be beneficial in reducing hillslope erosion. Remaining areas are small percentage of watershed, and broken up by steep slopes. Hillslope treatments are unlikely to be effective at reducing erosion rates
