Date of Report: 11/02/2021

ALISAL FIRE BURNED-AREA (BAER) REPORT

Los Padres National Forest
Santa Barbara Ranger District
November 2, 2021

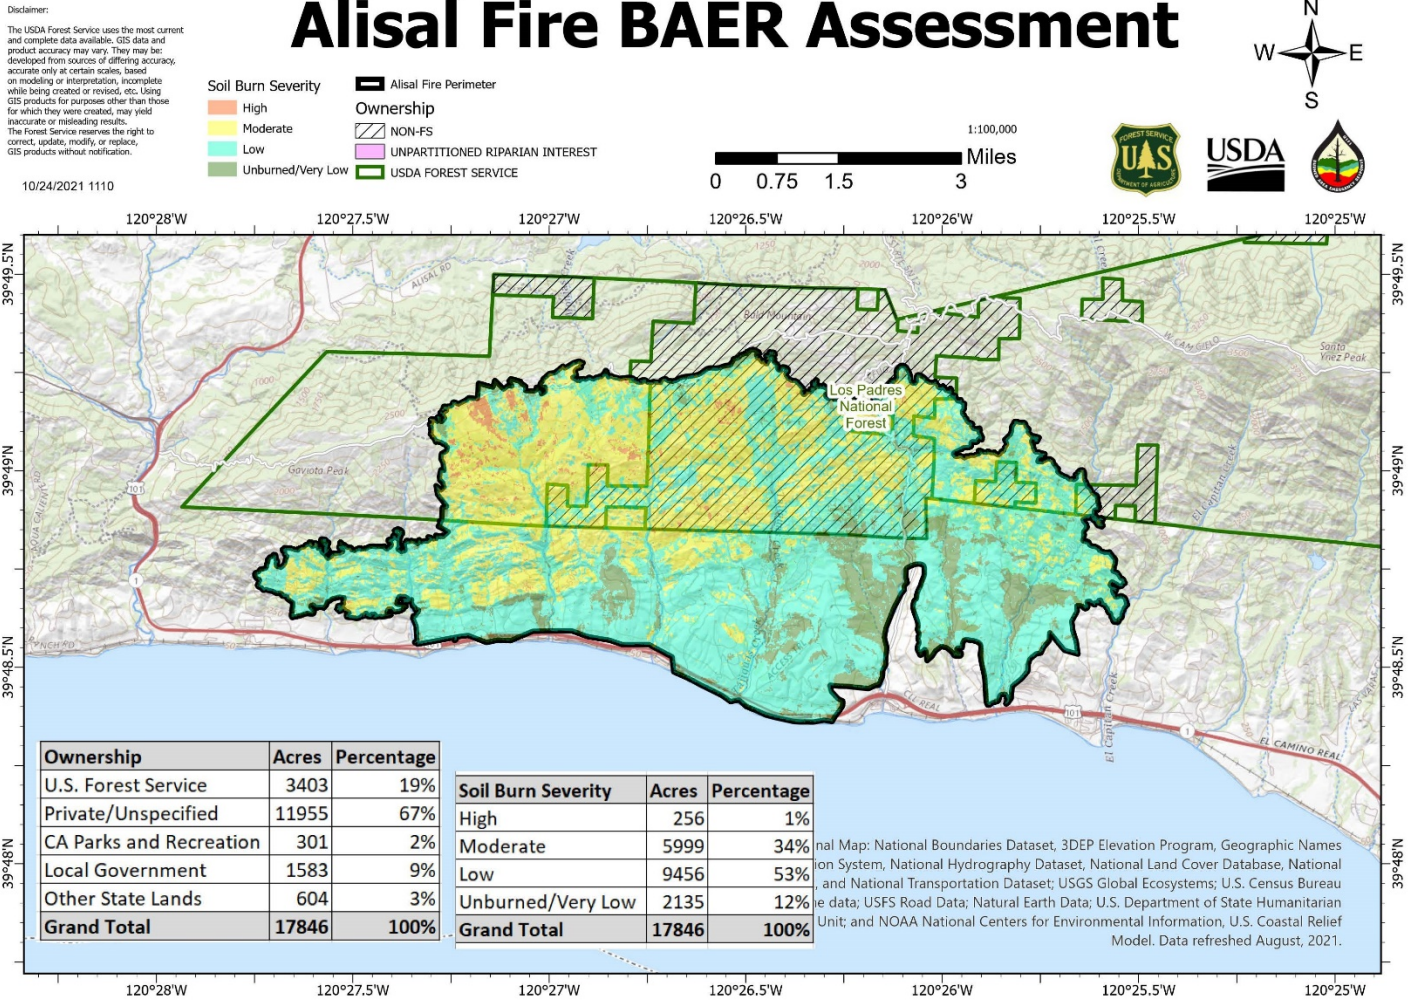
Figure 3: Soil Burn Severity Map of the Alisal Fire.

Soil Burn Severity	NFS	Private	CA State Parks	Local Gov	State	Total	% within the Fire Perimeter
Unburned	232	1,620	44	174	49	2,135	12
Low	987	7,067	211	847	240	9,456	53
Moderate	2,003	2,987	46	555	303	5,999	34
High	180	58	0	7	12	256	1
Total	3,403	11,731	301	1,583	604	17,846	100

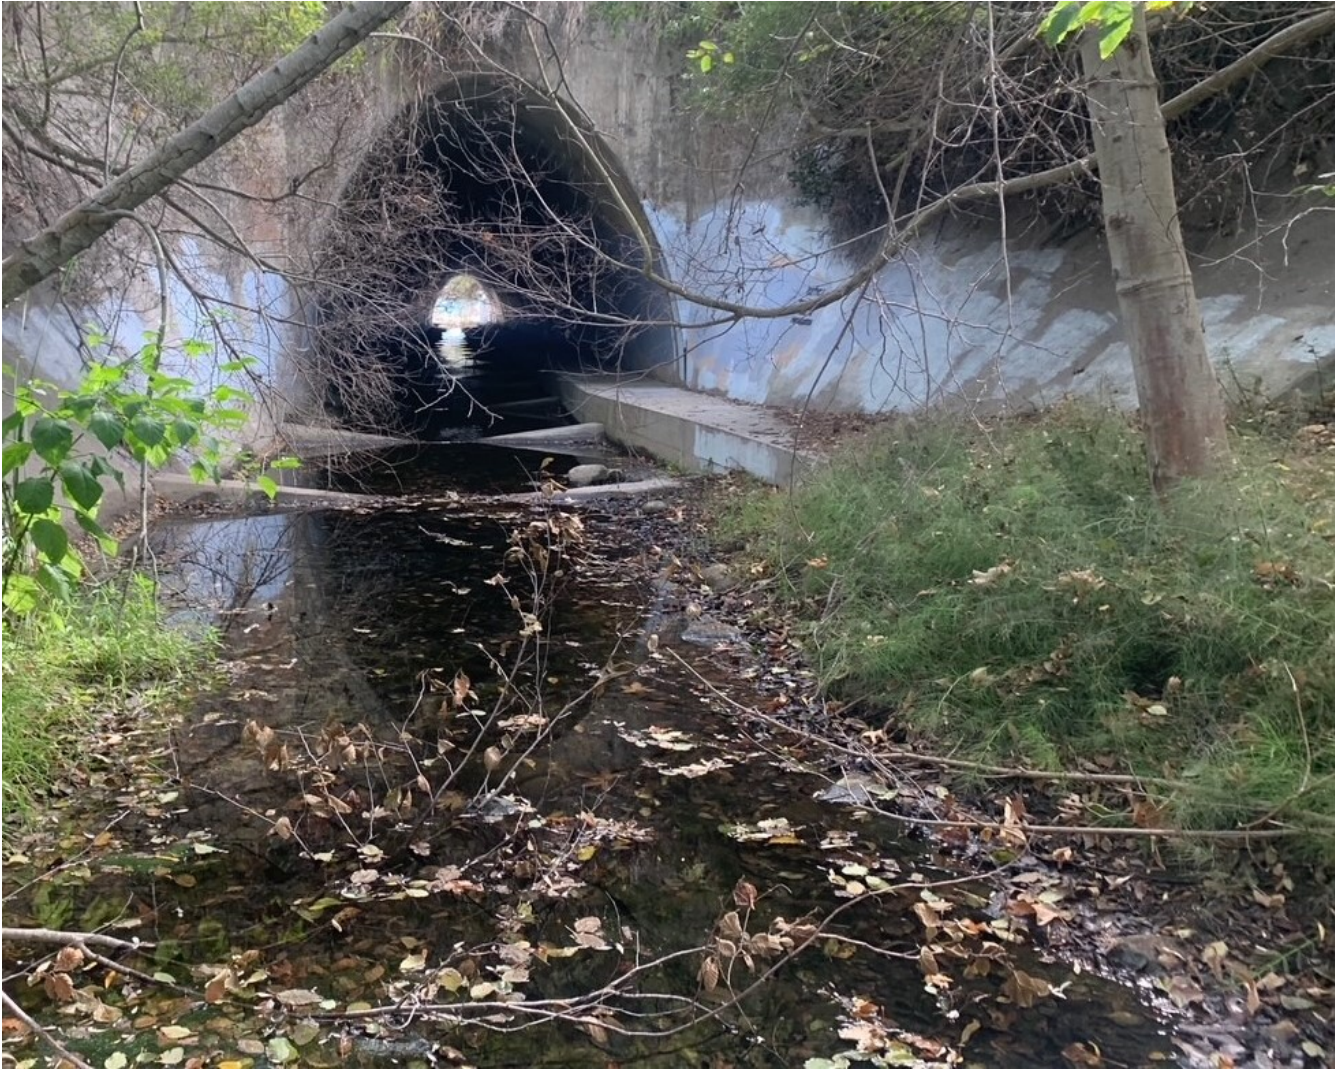
Photo of riparian habitat in Arroyo Hondo Creek.

Impacted stream systems are expected to be significantly impacted as a result of post-fire effects. Natural recovery of this system is projected to take 3-7 years, while sediment loads and debris flows are pushed downstream towards the ocean, and hydrophobic soils are broken down. However, recovery times are highly dependent on local precipitation. As elevated sediment loads and debris flows are processed through the river systems, breeding pools and emergent vegetation (CRLF) and deeper pools and redds (steelhead) are expected to reestablish along the stream channels.

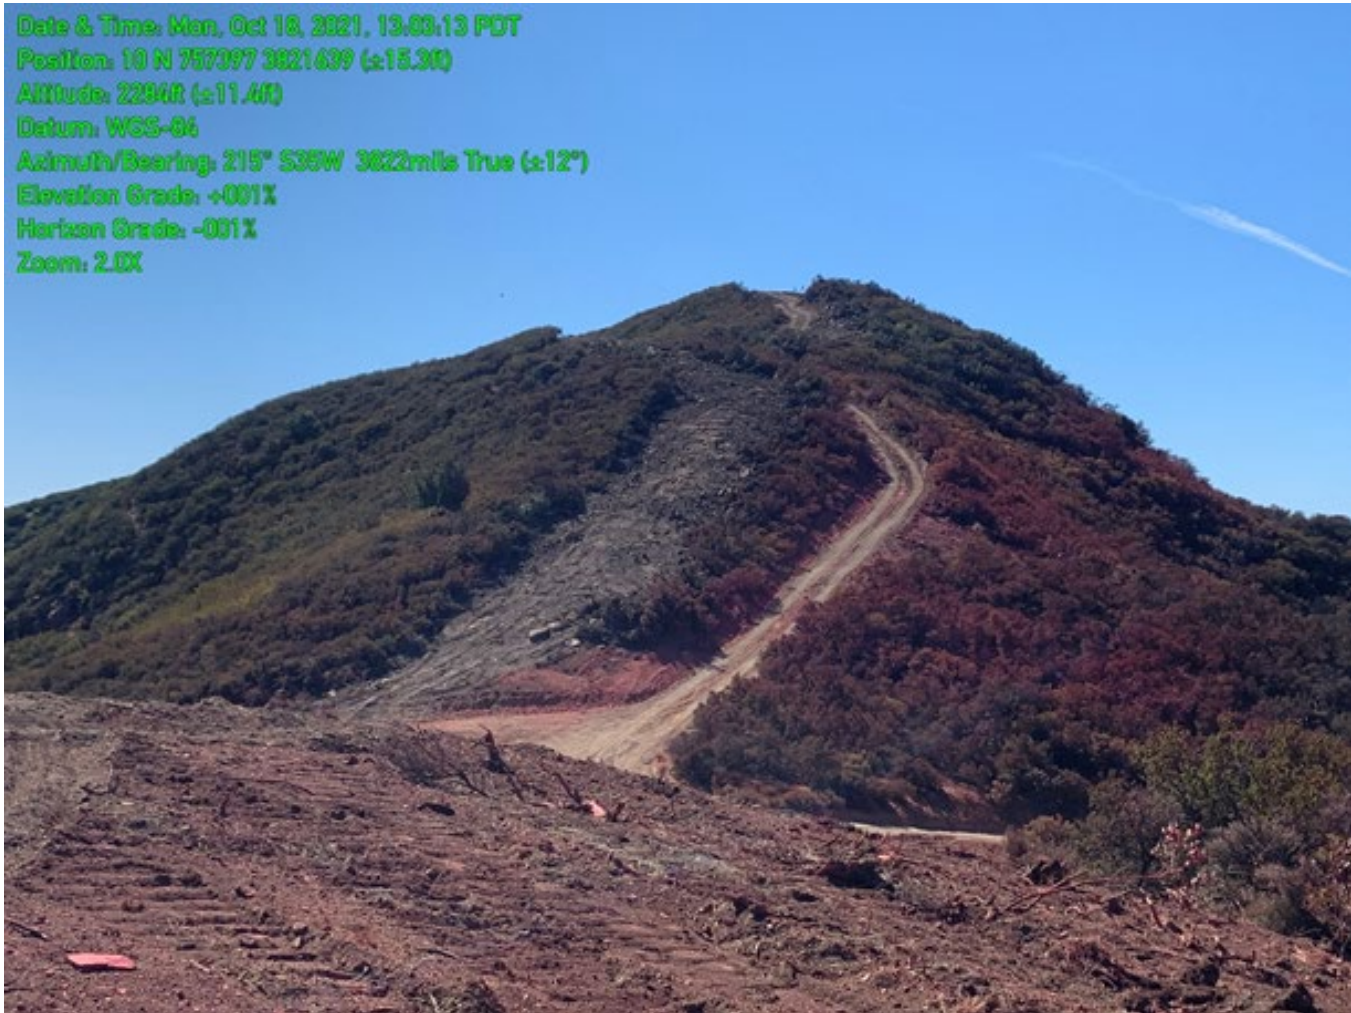
Approximately 4.74 miles of dozer lines were placed on Los Padres National Forest lands and it is crucial to prevent further spread of invasive plants into these areas. These dozer control lines have been used in many fires, including the recent Sherpa Fire, but new invasive plant introductions will not be detectable until one growing season, so additional survey and treatment will need to occur in 2022.

Photo of a contingency dozer line for the Alisa Fire near Gaviota Peak.

The treatment is invasive plant detection surveys of all roads, dozer lines, drop points, and safety zones affected by the Alisal Fire on NFS lands. These areas will be surveyed for evidence of introduction or spread of invasive plants. If any new or outlying populations are found, these will be mapped and documented for future treatment and where possible hand treatments will be applied at the same time the surveys are conducted. Approximately 4.7 miles of dozer lines were established on the Los Padres National Forest during this fire.
