**Telegraph Fire
Burned Area Emergency Response Assessment (BAER)
Executive Summary Report**

**Globe Ranger District
Tonto National Forest
July 9, 2021**

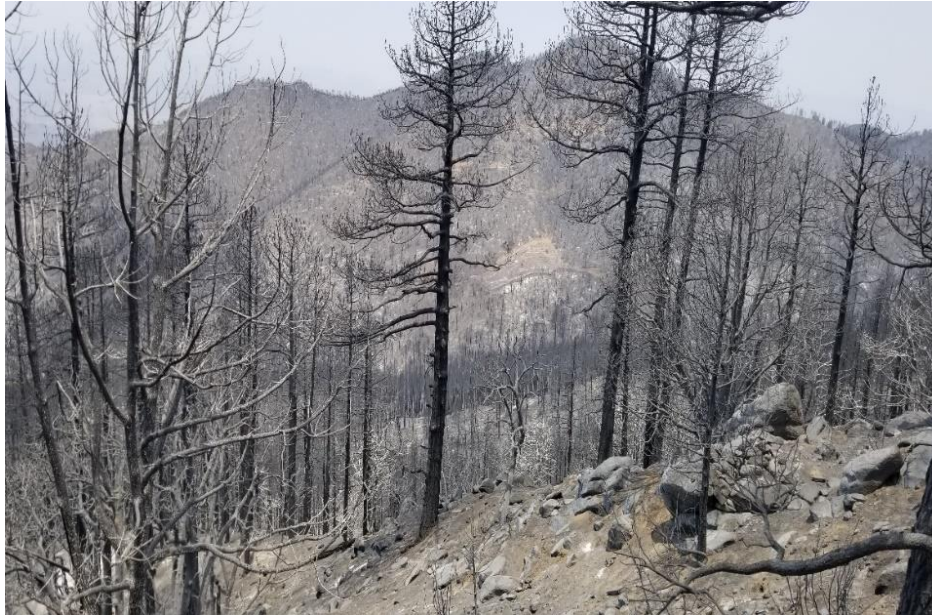
View from Madera Ridge Road looking northwest on June 17, 2021.

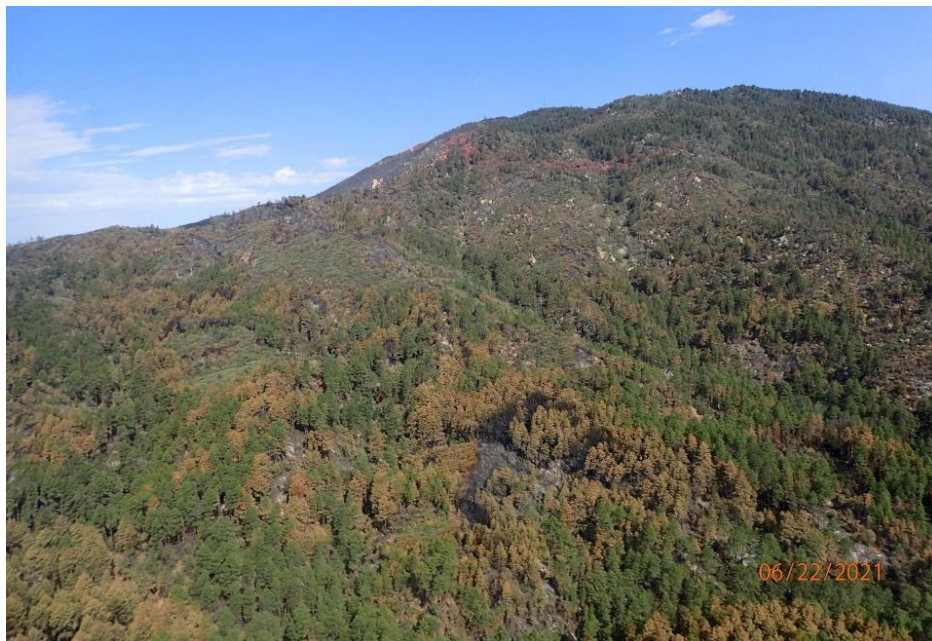
Aerial view of Pinal Ridge on June 22, 2021.
