2021 BACKBONE FIRE

Burned Area Emergency Response (BAER)

Assessment Report Summary

Coconino and Tonto National Forests

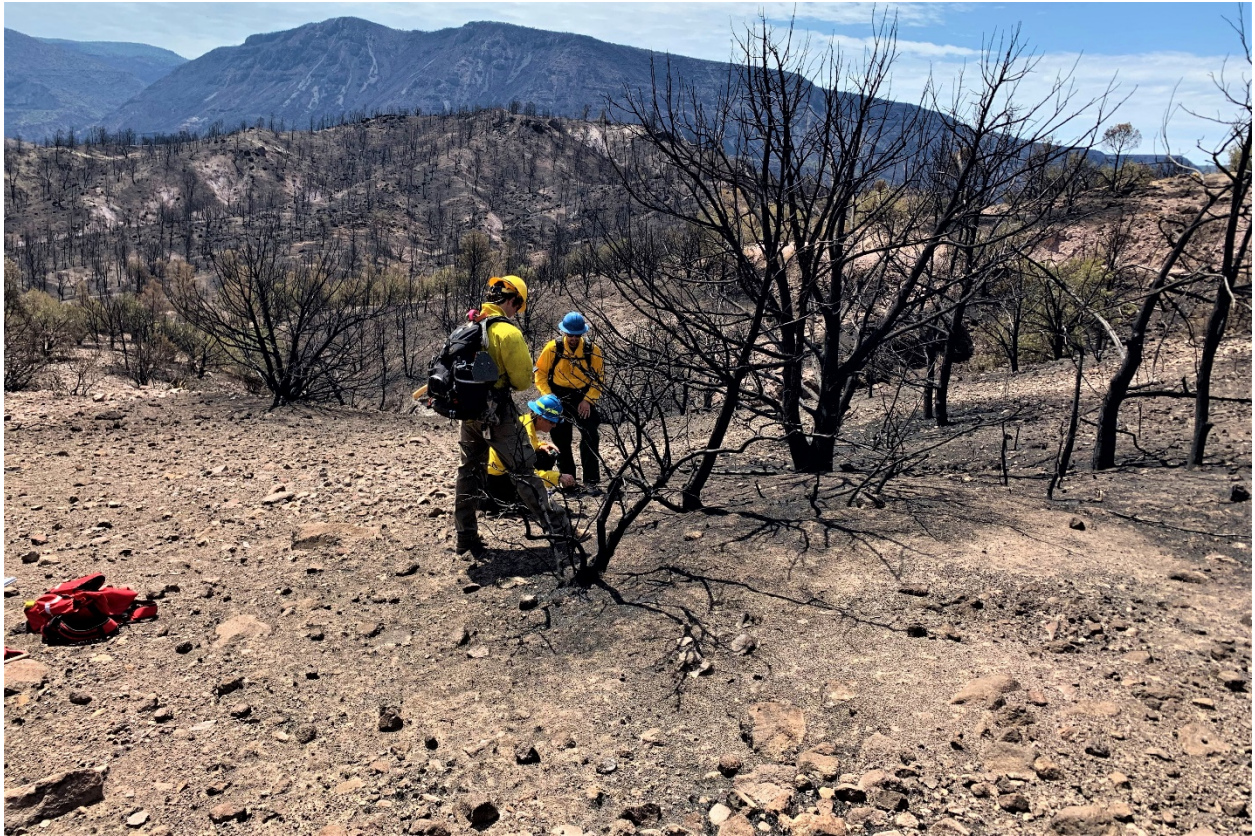
BAER Soil Scientists and Hydrologist Testing Soils in Backbone Burned Area for Water Repellency

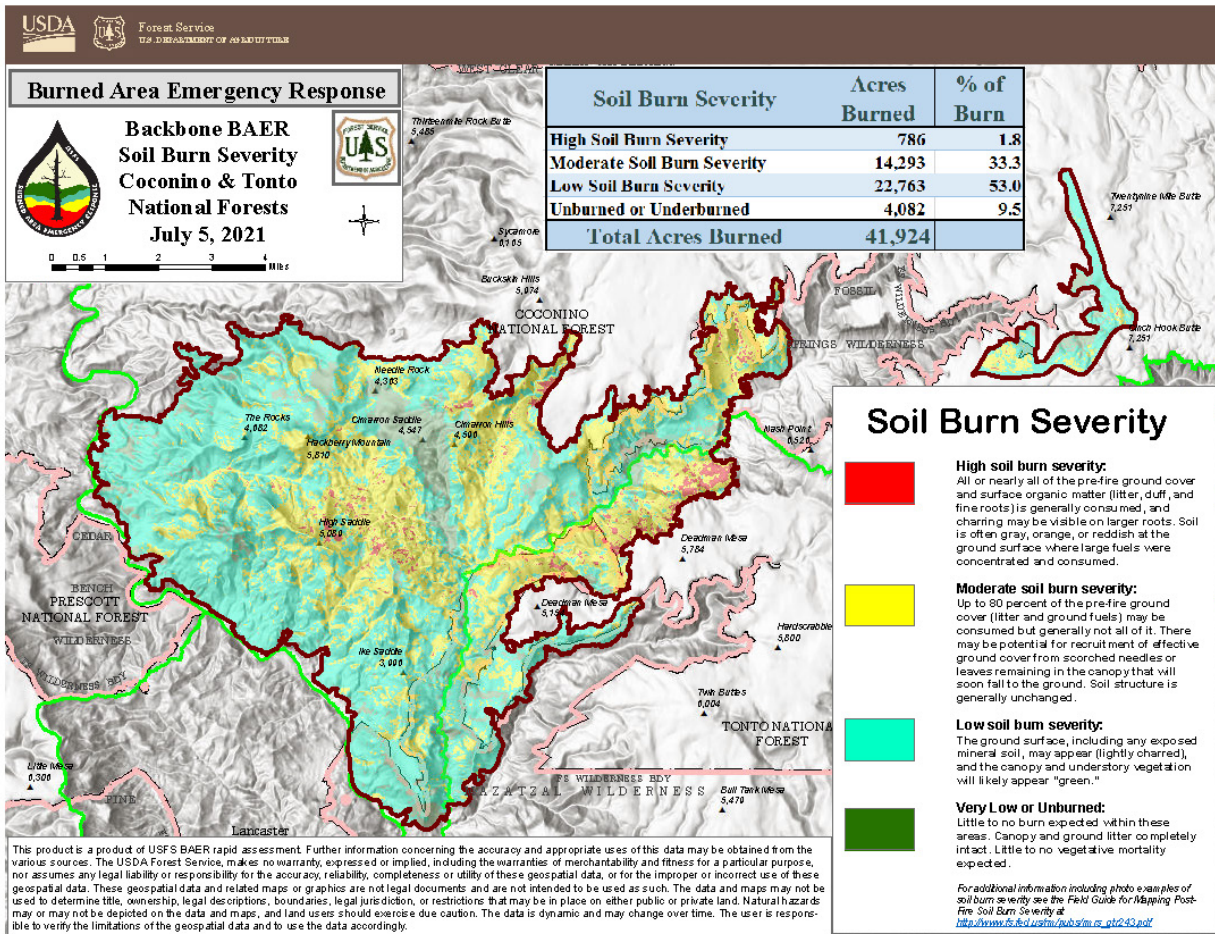
FIGURE 1:

Primary soil characteristics considered in soil burn severity classification are forest floor cover, ash color, integrity of roots, integrity of structure, and water repellency. Water repellent soils have reduced infiltration which results in increased runoff. Areas of low and unburned SBS have minimal effects to soil properties, and therefore, little to no post-fire effects. While moderate SBS indicates that some soil properties have been affected and the duff and litter layer that acts as a sponge to absorb precipitation has mostly been consumed. And high SBS areas have significant alterations to soil properties such as complete consumption of litter and duff, loss of root viability and changes to soil structure than often drive substantial watershed response including increased erosion and runoff following precipitation events. The team conducted its field verification surveys to adjust the initial satellite data to create a final SBS map for the Backbone burned area (See Figure 1).

Soil Burn Severity	Coconino NF	Tonto NF	Other	Total	% of NFS	% within Fire Perimeter
Unburned	3,505	578		4,083	10%	10%
Low	20,028	2,734		22,762	54%	54%
Moderate	11,382	2,906	4	14,288	34%	34%
High	370	416		786	2%	2%
