El Dorado Fire 2020

Date of Report: October 6, 2020

BURNED-AREA REPORT

A. Fire Name: El Dorado

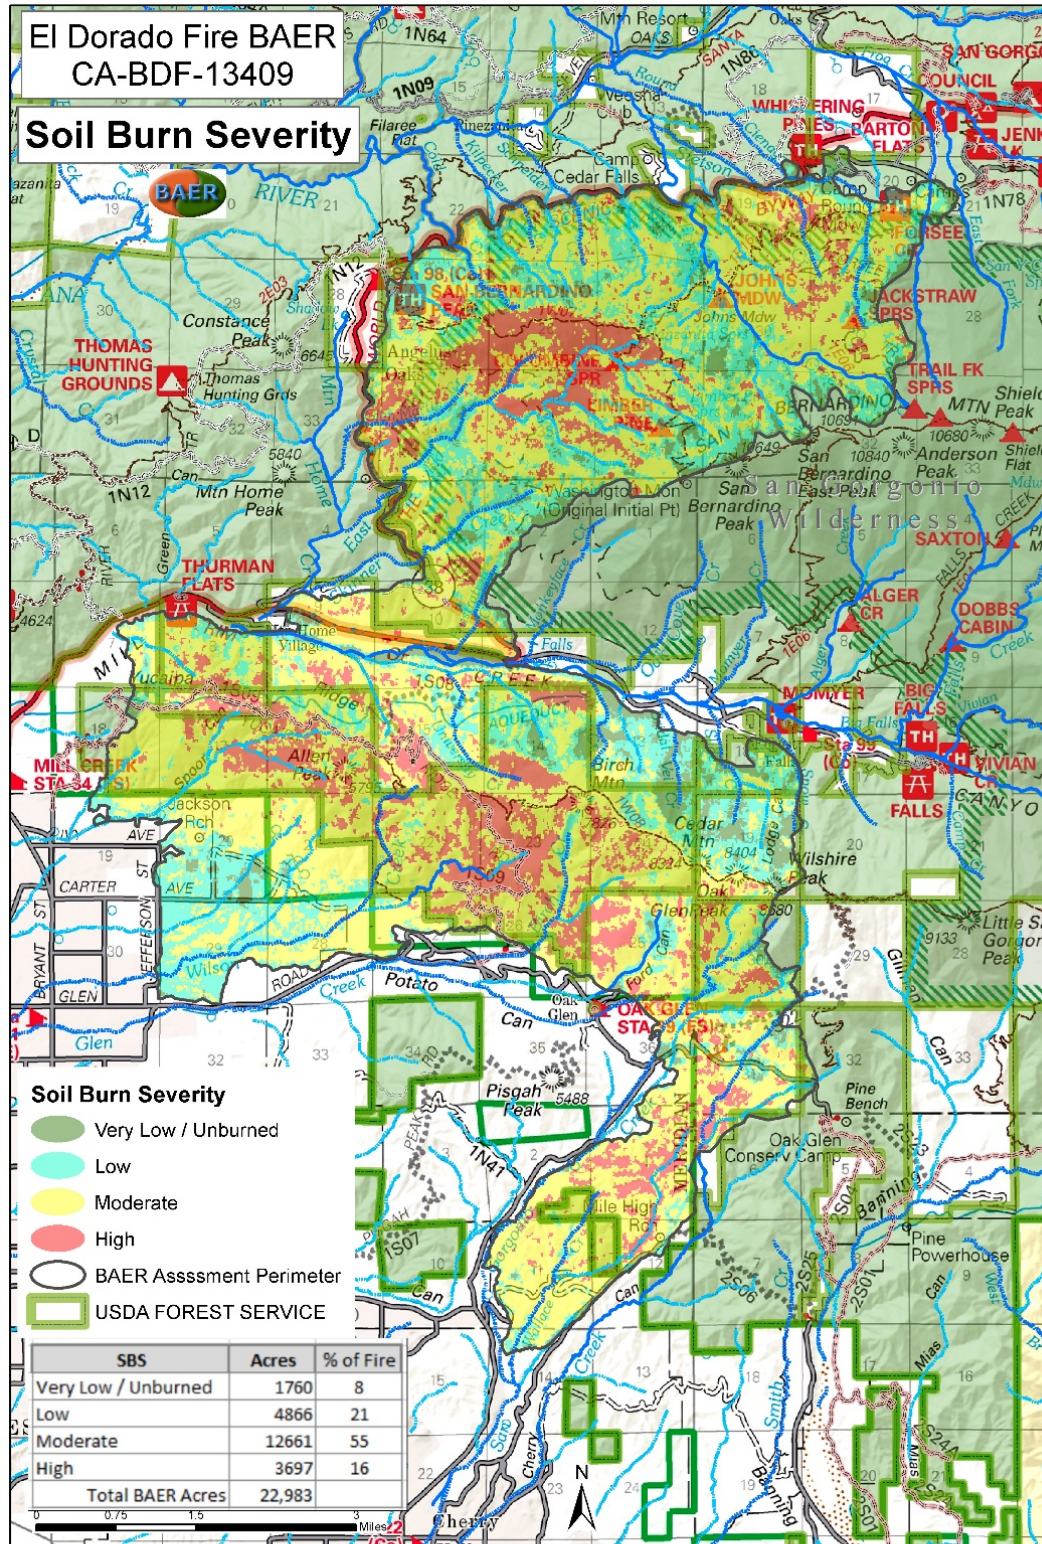
Figure 1: El Dorado Soil Burn Severity Map

Figure 1 below shows limitations that restrict the area available to hillslope treatments, such as aerial mulching. Figure 1A shows soil burn severity within the El Dorado Fire. Low and very low burn severities are greyed out in 1B because these SBS classes typically retain ground cover and erosion rates are low. 1C blacks out slopes that are steeper than 60%, where hillslope treatments are not effective, and less than 10% where runoff energy is low and treatments are not necessary. Finally, 1D grays out non-Forest Service lands and wilderness where the forest service can not recommend treatments. The remaining areas, shown in red and yellow on 1D are slopes where hillslope treatments such as aerial mulching could technically be beneficial in reducing hillslope erosion. Remaining areas are small percentage of watershed, and broken up by steep slopes. Hillslope treatments are unlikely to be effective at reducing erosion rates
