Date of Report: 11/02/2021

ALISAL FIRE BURNED-AREA (BAER) REPORT

Los Padres National Forest
Santa Barbara Ranger District
November 2, 2021

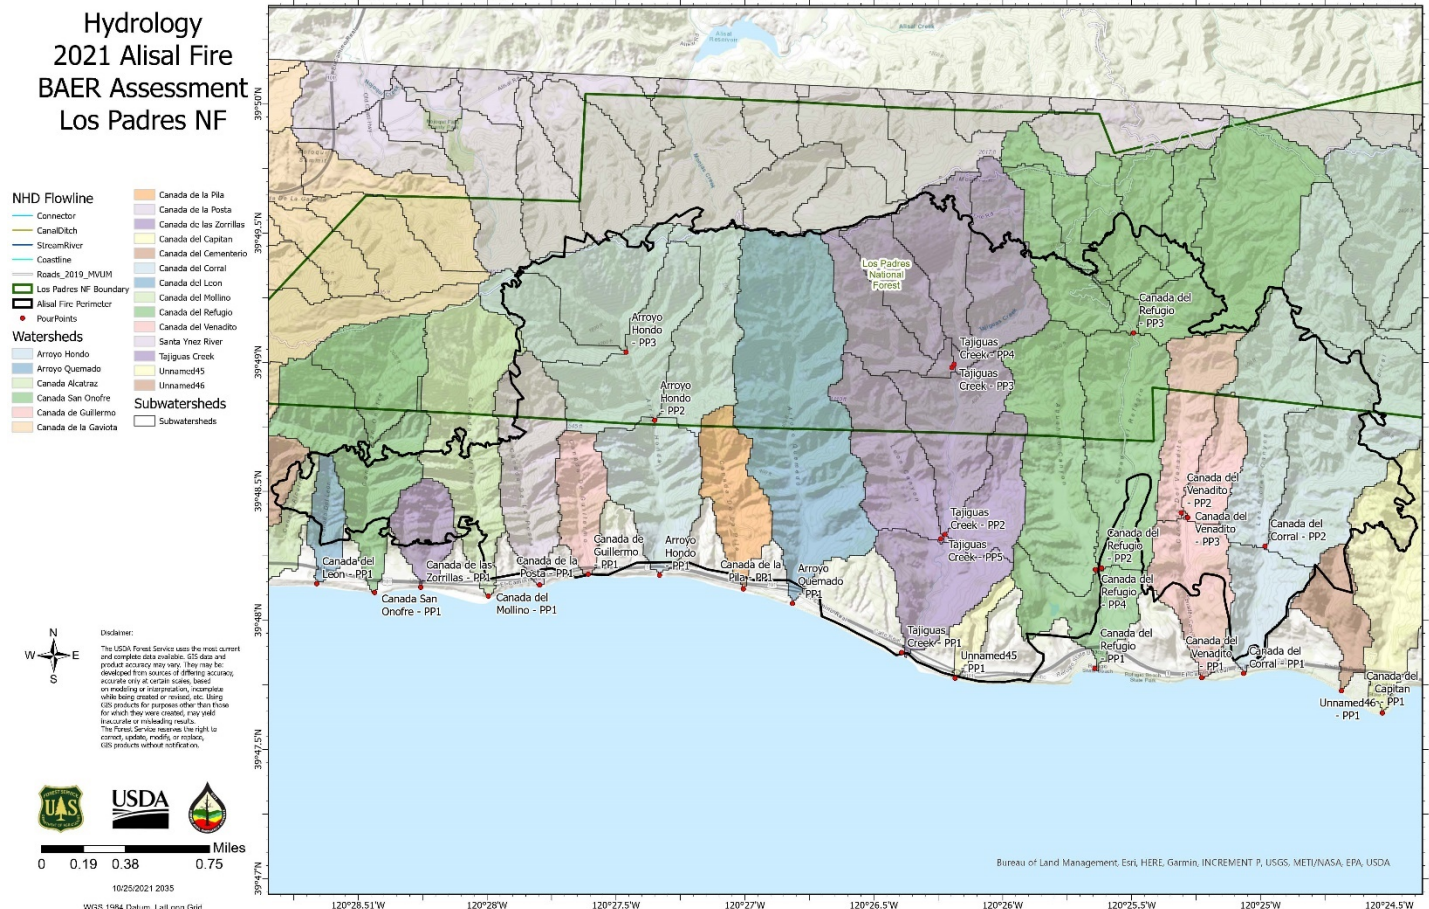
Figure 1: Watershed impacted by the Alisal Fire and hydrological model pourpoints

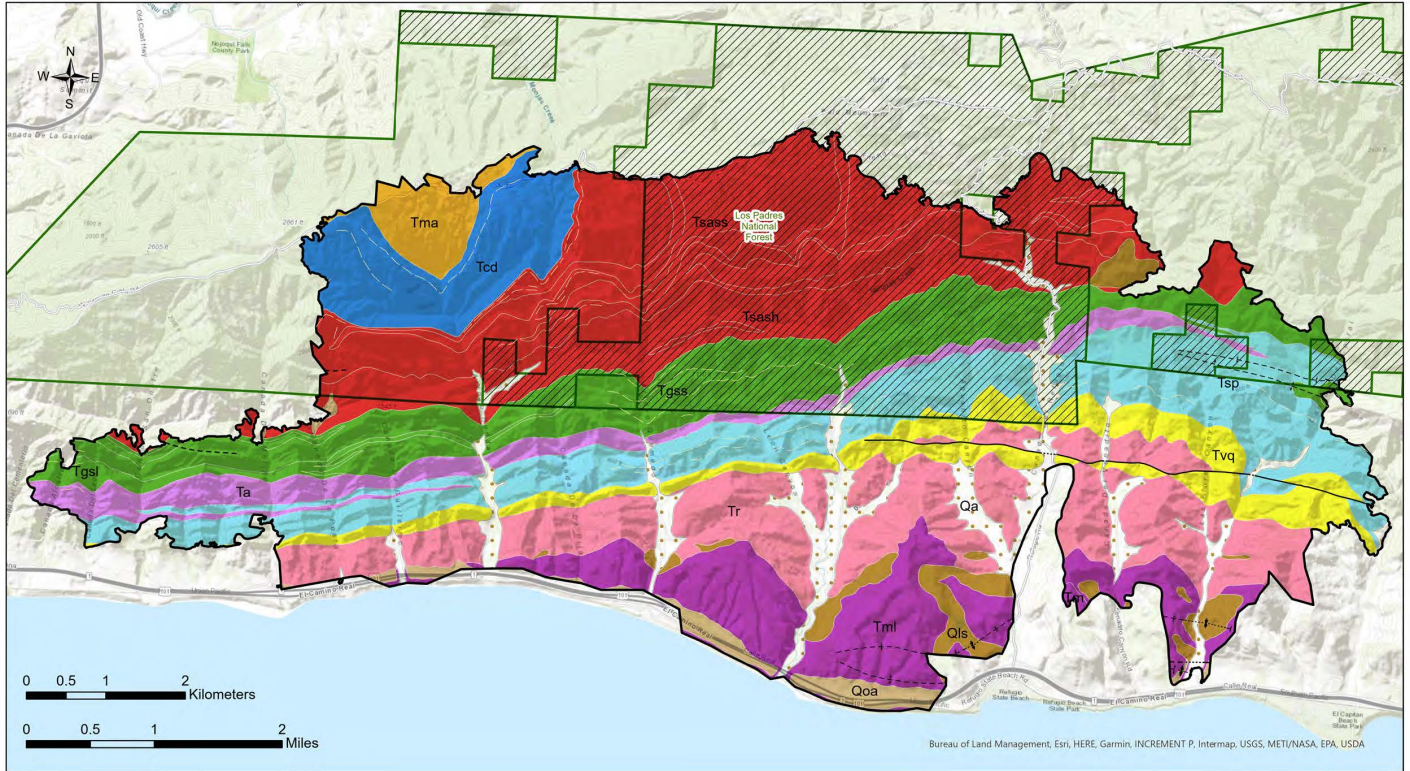
Bedrock within the boundaries of the Alisal Fire is underlain entirely by sedimentary rock formations, ranging in age from the oldest Eocene (~60 million years old) to younger Miocene (~25 million years old), and overlain by Quaternary alluvial and surficial sediments to present age. The majority of those rock types are of sandstone or shale composition with some conglomerate (Figure 2). Geological units in the area have been assigned to the following formations: Matilija Sandstone, Cozy Dell Shale, Sacate Sandstone, Gaviota Sandstone, Alegria Sandstone, Sespe Formation, Vaqueros Sandstone, Rincon Shale, and the Monterey Shale. These formations are listed in order of decreased age. In addition to these formations there are also Quaternary age materials including older alluvium from the Pleistocene, landslide rubble, and younger alluvium from the Holocene. Strata of all the other rock types typically dips steeply, usually towards the south and southwest, but sometimes overturned and dips towards the northeast. Numerous faults cross the fire area, trending east-west to northwest and include the Refugio fault and Santa Ynez fault that is just to the north of the burn scar.

Figure 2: Geology map of the area impacted by the Alisal Fire
